OPERATING INSTRUCTIONS

MODEL BPS-05 #150 FLG

BACK PRESSURE VALVE

<small>PH 973-340-9955 FX 973-340-9933 25 COLUMBUS AVE GARFIELD, NJ 07034</small>	
<small>MATL SEE ABOVE SCALE NONE DATE 9-5-06 DRWN EDS</small>	<small>TITLE RELIEF VALVE ST. STEEL 1/2"-4" MODEL BPS05-FLG DWG NO BPS05-150#FLG REV D</small>

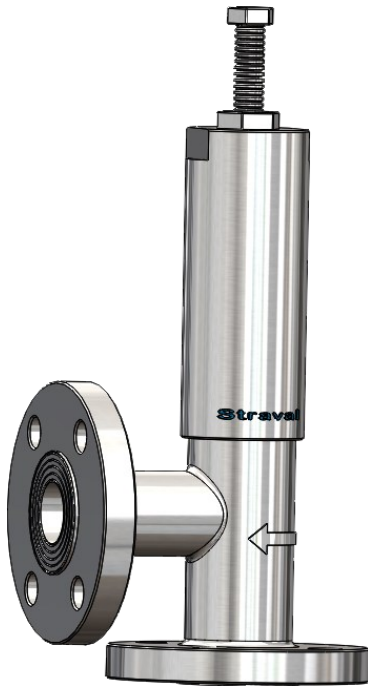
MATERIAL LIST & SPECIFICATION			
1	ADJUSTING SCREW	STEEL	
2	LOCK NUT	STEEL	
3	SPRING CHAMBER	STEEL	
4	SPRING PUSHER	STEEL	
5	ADJUSTING SPRING	STEEL	
6	SPRING CARRIER	STEEL	
7	POPPET	ST. STEEL	
8	BODY	ST. STEEL	
9	SEAL	VITON

DIMENSIONS			
SIZE	"A" (IN)	"B" (IN)	"C" (IN)
1/2	2 1/2	2 1/2	8 7/8
3/4	2 3/4	2 3/4	9 3/4
1	2 3/4	3	11 1/8
1 1/4	3	3 1/2	12 1/4
1 1/2	3	4	13 1/2
2	3 1/2	4 1/2	15 1/2
2 1/2	4	5	18 1/2
3	5	5 1/2	21
4	6	6	23

150# ANSI RF FLANGES STAINLESS STEEL
A & B will increase for higher flange ratings
Request installation dwg from factory

This is a poppet and spring type backpressure valve where the spring constantly opposes the pressure acting against the poppet, which seals off the inlet port from the outlet port at the valve seat. The desired set pressure or control pressure is achieved by compressing the spring until the spring force is adequate to balance the pressure force acting against the poppet. When the inlet pressure exceeds the set pressure, the poppet will open to relieve the excess pressure.
